Evaluation of Advance Warning Signal Installation Phase I Summary Presentation

PREPARE TO STOP

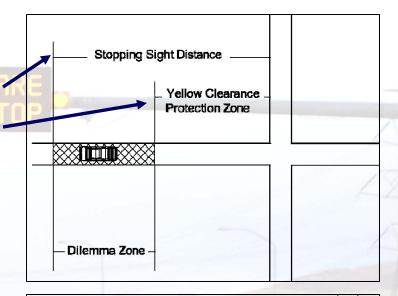
- Dilemma zone (DMZ):
 - Not enough distance to stop
 - Not enough time to proceed
 - Improper signal timing
- Decision zone (DCZ):
 - Variation in driver behavior
 - Design assumptions not met
 - Motorists caught unaware
 - 90% 10% probability stopping distances

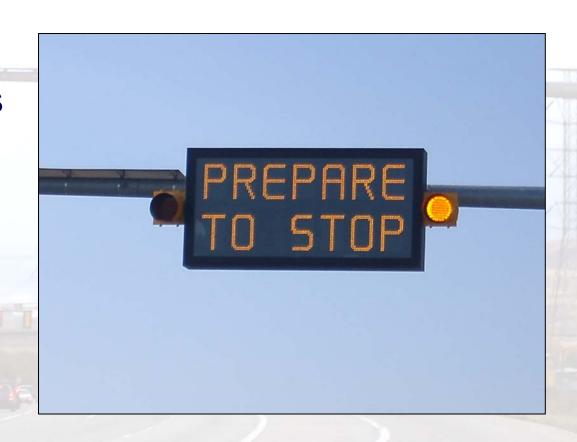
DESIGNThe Signs

- "Blank-Out" LED with sidemounted flashers
- Two rows of 14" letters
- 48" x 96" x 12" 300 lbs
- State-Furnished Item

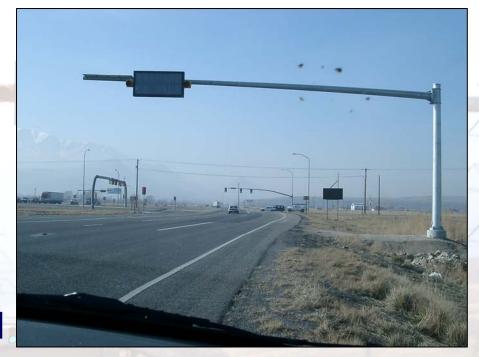
DESIGNThe Installation

- Standard 75' mast arm and signal pole with mast arm cut to 55' length
- Horizontal damping "wing" at end of arm (2' x 8' panel)
- 65 mph design speed

- AWS placed 445' from stop bar; luminaire and video camera at 705'; detection zone at 755':
 - Based on a 2002 Nebraska Department of Roads study

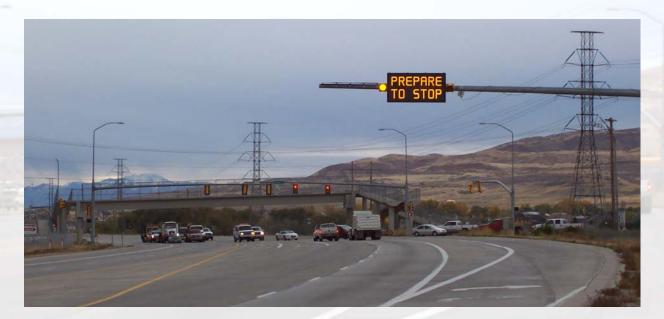
SIGNAL TIMING

- AWS comes on 6 seconds before end of green (lead-flash time)
- AWS remains on during the red
- AWS turns off once arterial turns green

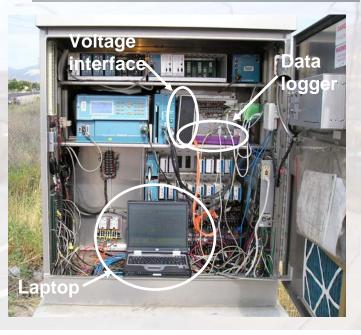
EVALUATIONData Collection Equipment – 13400 South

- BYU partnered with Wavetronix LLC to collect data using:
 - SmartSensor Advance[™] digital wave radar
 - Wireless communication devices
 - Contact closure devices
- In addition, UDOT provided the following equipment:
 - Voltage interface
 - Data logger
 - Laptop computer

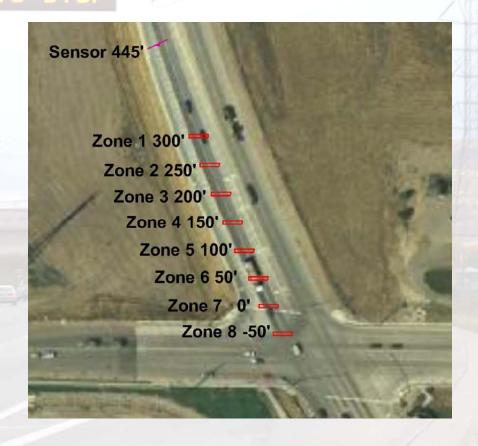
EVALUATION Data Collection Equipment – 13400 South

- Speeds are recorded for each vehicle in 8 zones
- Red signal phases are time stamped
- Signal data is logged in the datalogger
- Speed data is logged on the laptop computer
- Post processing of the signal data and speed data allows red-light runners to be identified

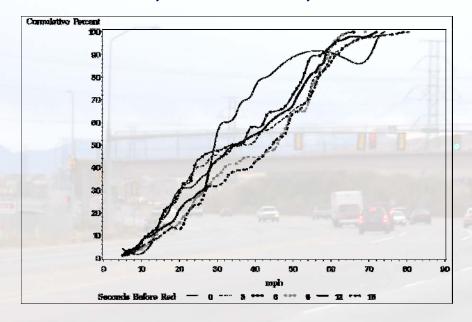
Before, Northbound, 100 ft

- Speed data cumulative distributions:
 - Organized by time of day, approach, sensor zone, and number of seconds before red

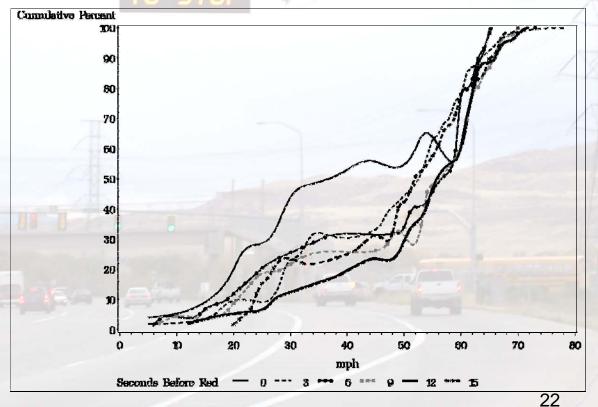
Immediately After

EFFECTIVENESS ight-month After Results

- Eight months after the system was installed:
 - Speed distributions returned to similar trends as before installation
 - Red light running increased to levels slightly higher than before installation in some instances
 - Crash rates decreased
 - Decision zone remained relatively constant
- Lead flash time theorized to be too conservative
